SRX LP

LANDFILL PUMP

SRX LP Landfill Pump

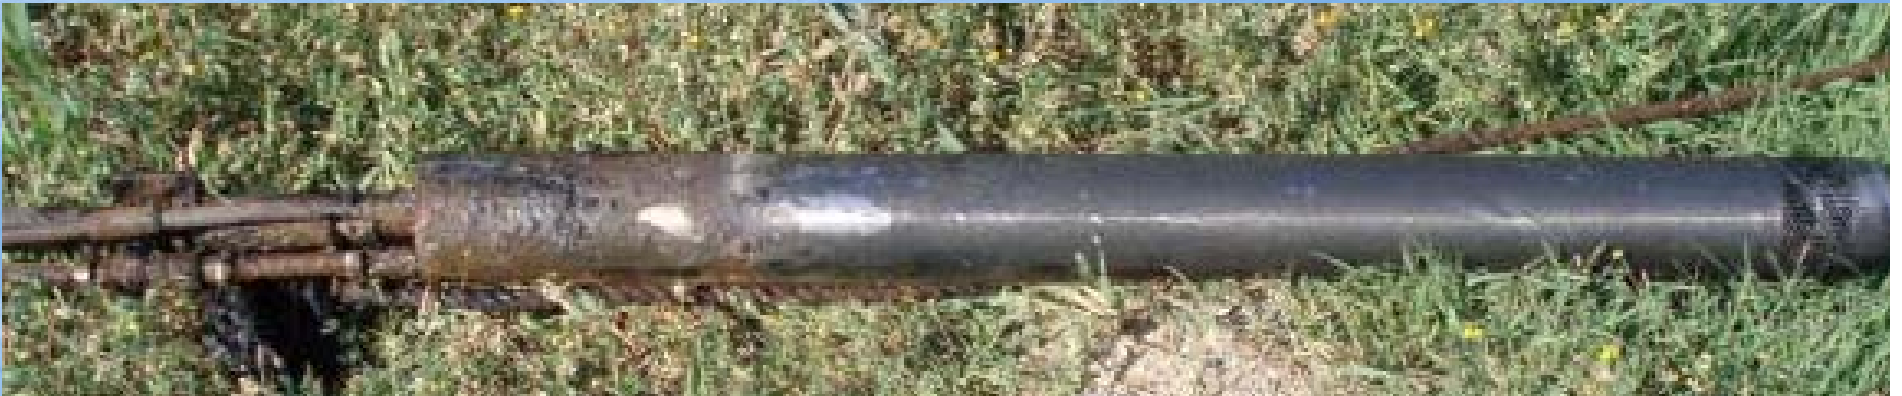
The SRX LP Pump was removed from the well for inspection and cleaning after five months of trouble free operation.

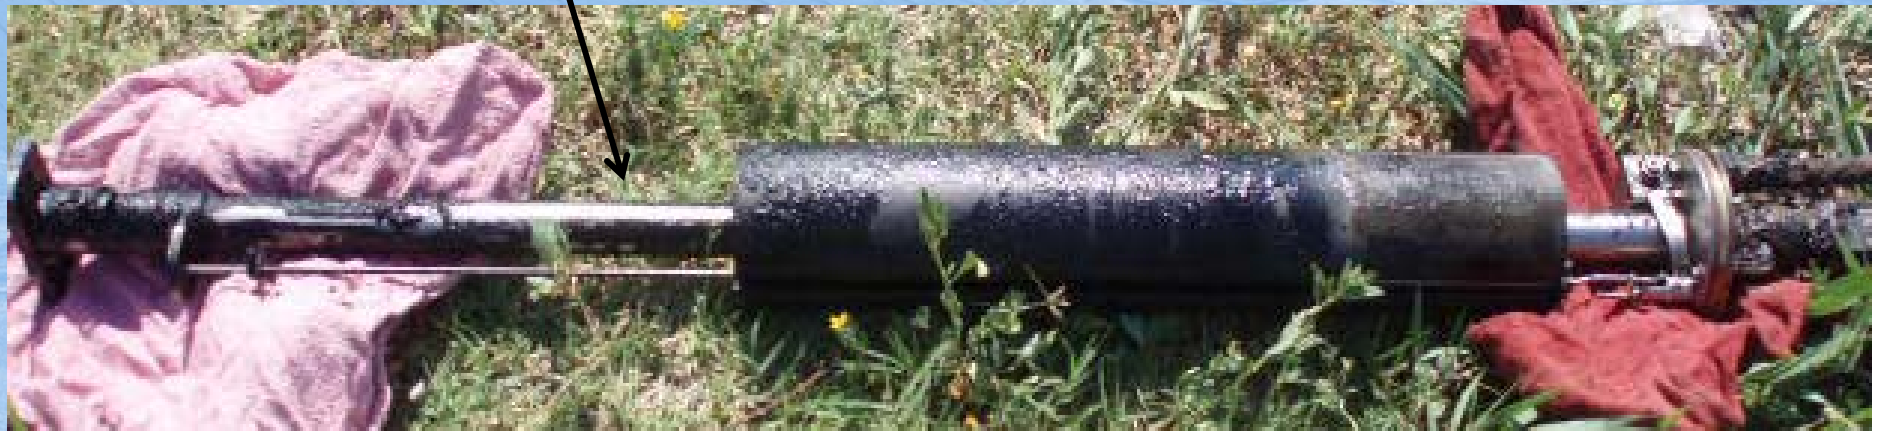
Minimal build-up occurred on the center discharge tube. This is primarily due to the polished OD of the discharge tube and the movement of the hard surface Ebonite Float
